**DEPARTMENT OF TRANSPORTATION**

Contract #: 04-0120F4Cty: SF/ALA Rte: 80 PM: 13.2/13.9File #: 69.28**WELDING INSPECTION REPORT****Resident Engineer:**Pursell, Gary**Address:** 333 Burma Road**City:** Oakland, CA 94607**Report No:** WIR-012580**Date Inspected:** 11-Mar-2010**Project Name:** SAS Superstructure**OSM Arrival Time:** 700**Prime Contractor:** American Bridge/Fluor Enterprises, a JV**OSM Departure Time:** 1900**Contractor:** Zhenhua Port Machinery Company, Ltd (ZPMC), Changxing Island **Location:** Shanghai, China**CWI Name:** Li Yang**CWI Present:** Yes No**Inspected CWI report:** Yes No N/A**Rod Oven in Use:** Yes No N/A**Electrode to specification:** Yes No N/A**Weld Procedures Followed:** Yes No N/A**Qualified Welders:** Yes No N/A**Verified Joint Fit-up:** Yes No N/A**Approved Drawings:** Yes No N/A**Approved WPS:** Yes No N/A**Delayed / Cancelled:** Yes No N/A**Bridge No:** 34-0006**Component:** OBG**Summary of Items Observed:**

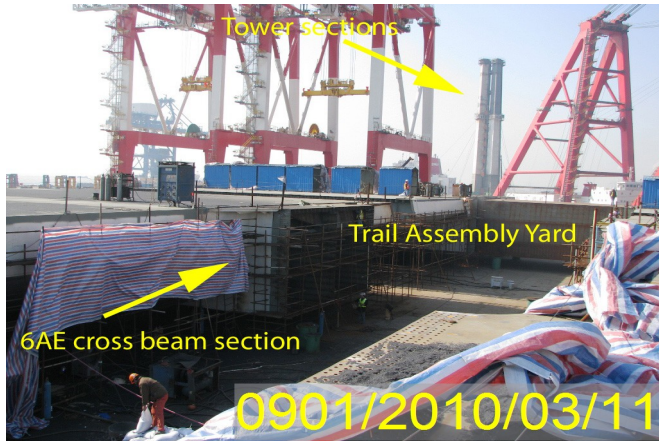
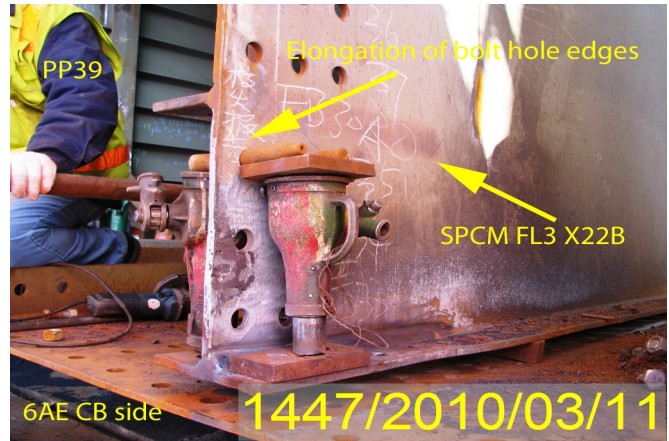
During random in process observations of 6AE at OBG Trail Assembly line, this QA Inspector observed heat straightening was performed on FL3 plate member damaged at panel point (PP) 39 without an approved HSR. Contractor submittal AFC-CAL-TRN-0056649 and HSR (B)-357 procedure was present at time of work and states “area is damaged beyond the corrective means of heat straightening. Please submit an alternative repair procedure.” Submittal was stamped “Return for correction” by Caltrans Structural Representative on 03-03-10. This QA Inspector issued an incident report for today’s work shift.
